Diagnosis of split fractures of the mandible in adults

Background: Mandibular split fractures, in which the fracture occurs exclusively in the posterior wall, are uncommon. This study aimed to enhance clinicians' understanding of mandibular split fractures and offer insights for future research.

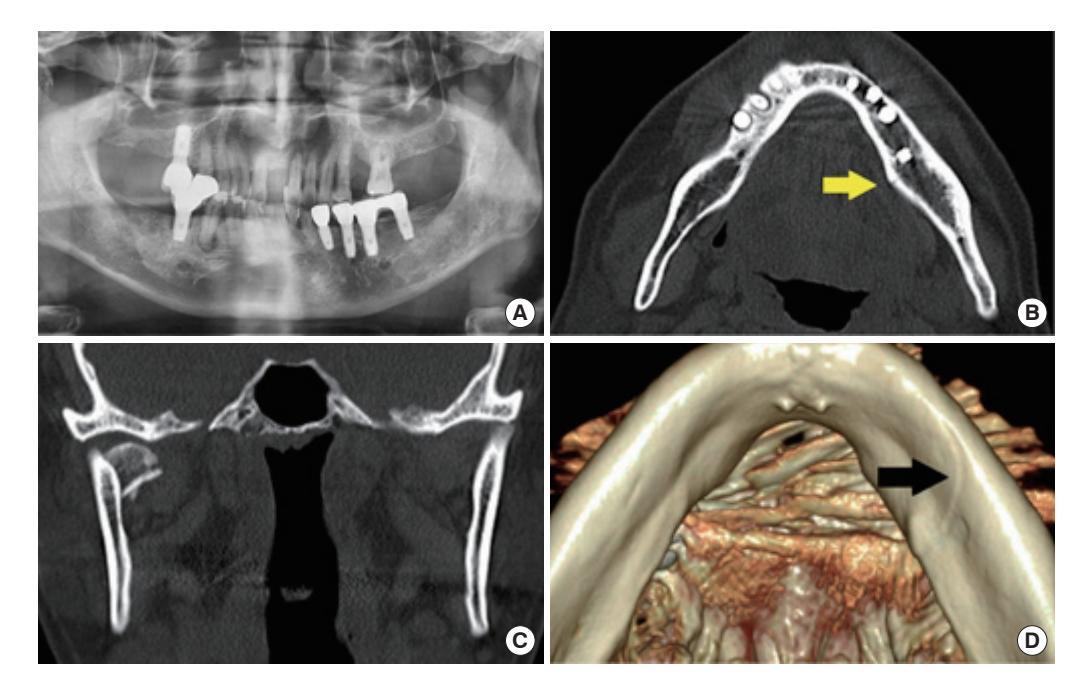
Fig. 1. A 60-year-old man with jaw trauma resulting from a slip-down incident. (A) Preoperative panoramic radiograph showing a fracture of only the right condylar head. (B) Axial view of computed tomography (CT) shows a split fracture of the left parasymphysis to body (yellow arrow). (C) Coronal view of CT shows a fracture of the right condylar head. (D) Three-dimensional reconstructed view of CT shows a split fracture (black arrow).

In all six patients diagnosed with mandibular split fractures, the fracture line was not readily apparent on panoramic radiography, but was definitively confirmed using CT scans and threedimensional (3D) reconstructed images (Figs. 1-5). The ages of the patients varied widely, ranging from 20 to 71 years (20, 25, 28, 60, 69, and 71), with a mean age of 49.8 years. The sex distribution was equal among the patients, with three men (50%) and three women (50%). The majority of the patients (4/6, 66.7%), sustained their injuries from slip-and-fall incidents. The remaining two patients (33.3%) were injured in collisions with another vehicle while riding a motorcycle.

(Figs. 1-5). Of the six patients, four (66.7%) presented with condylar head fractures, with one of these patients (16.7%) having fractures in both condylar heads. In two patients (33.3%), split fractures were the only type of fracture present.

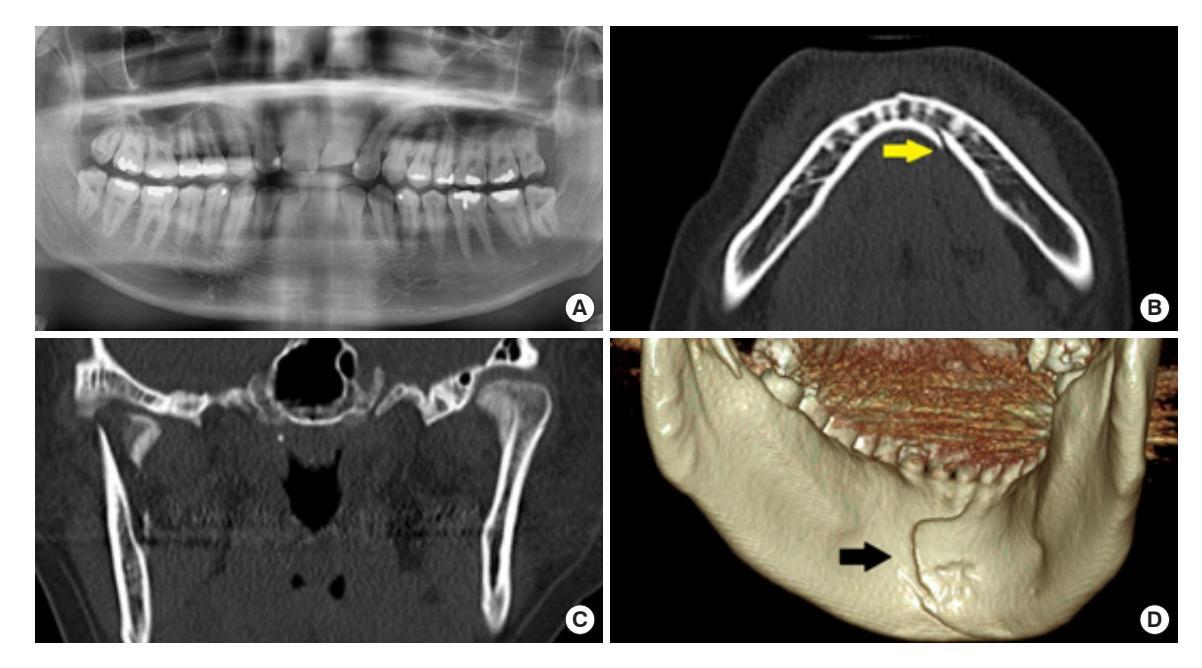
Fig. 2. A 25-year-old man with jaw trauma resulting from a motorcycle traffic accident. (A) Preoperative panoramic radiograph presenting fractures of only both condylar heads. (B) Axial view of computed tomography (CT) shows a split fracture of the symphysis to the left parasymphysis (yellow arrow). (C) Coronal view of CT shows fractures of both condylar heads. (D) Three-dimensional reconstructed view of CT shows a split fracture (black arrow).

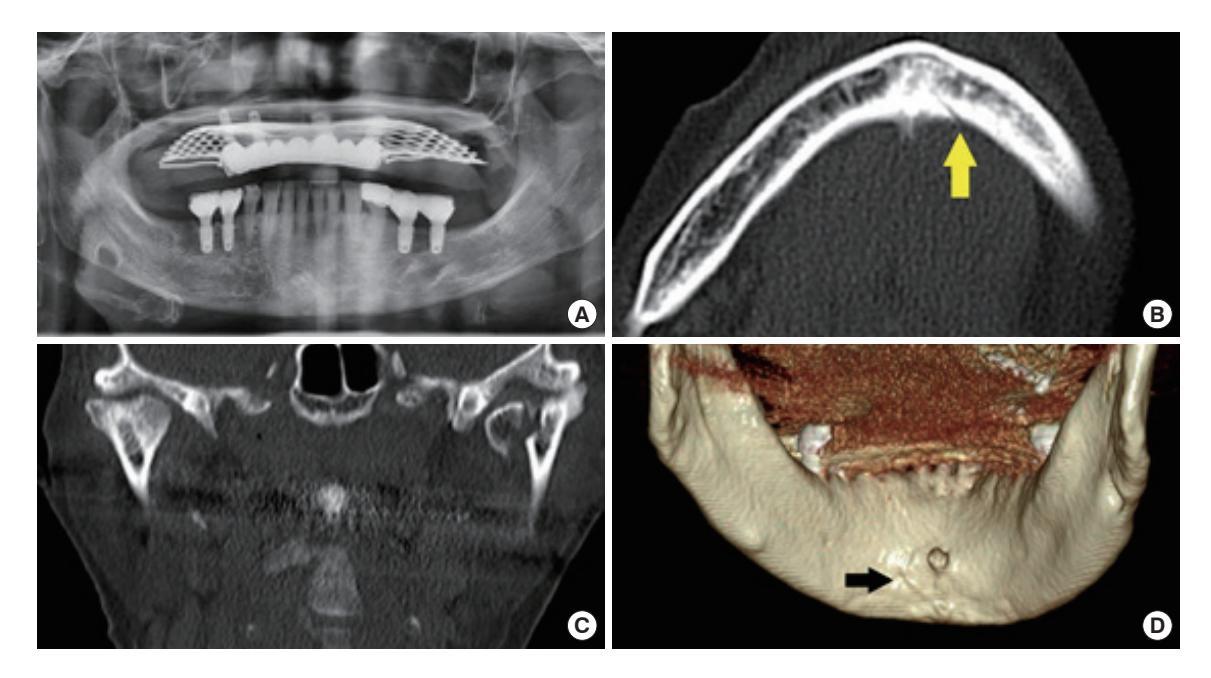
Fig. 3. A 69-year-old woman with jaw trauma resulting from a motorcycle traffic accident. (A) Preoperative panoramic radiograph showing a fracture of the left condylar head only. (B) Axial view of computed tomography (CT) shows a split fracture of the symphysis to the left parasymphysis (yellow arrow). (C) Coronal view of CT shows a fracture of the left condylar head. (D) Three-dimensional reconstructed view of CT shows a split fracture (black arrow).

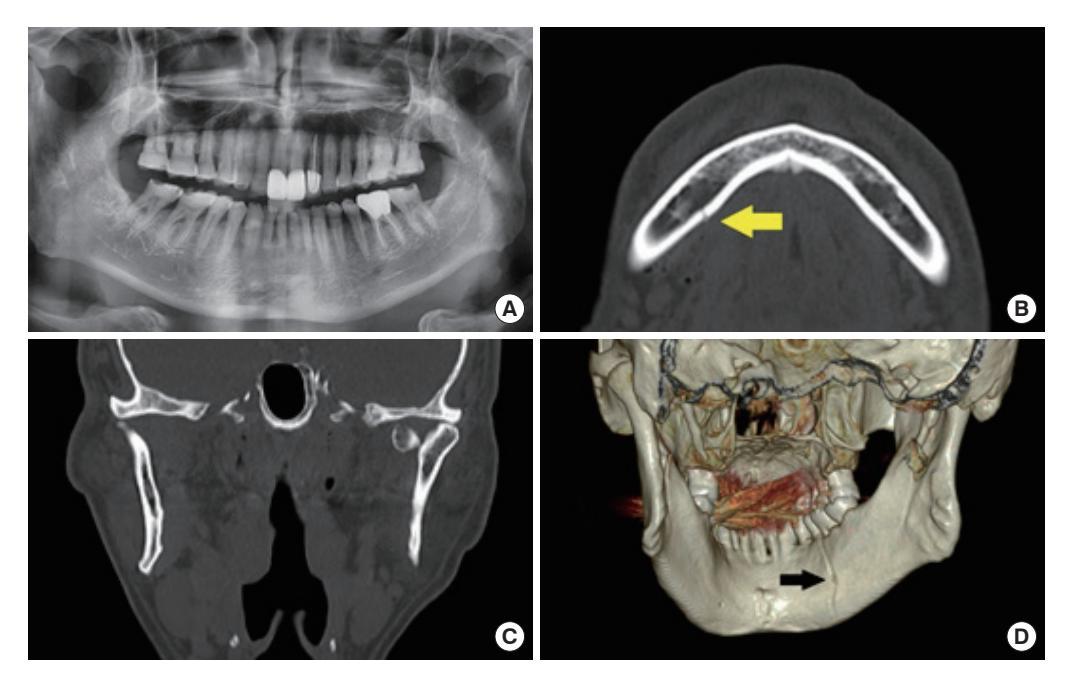
Fig. 4. A 71-year-old man with jaw trauma resulting from a slip-down incident. (A) Panoramic radiograph presenting a fracture of the left condylar head only. (B) Axial view of computed tomography (CT) shows a split fracture of the right parasymphysis (yellow arrow). (C) Coronal view of CT shows a fracture of the left condylar head. (D) Three-dimensional reconstructed view of CT shows a split fracture (black arrow).

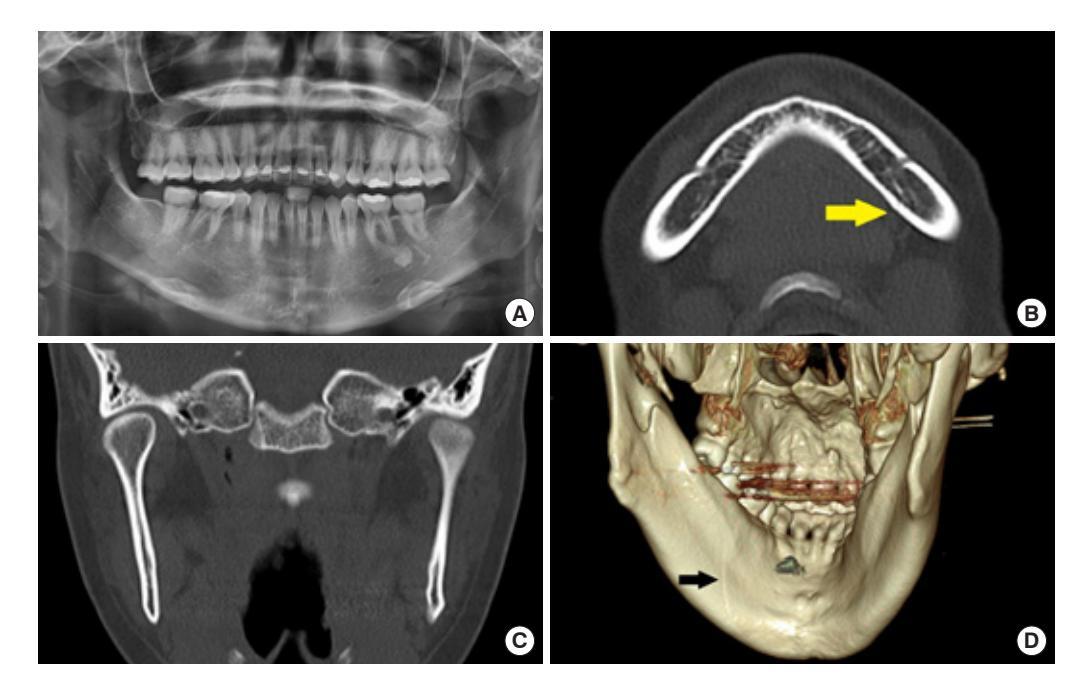
Fig. 5. A 28-year-old woman with jaw trauma resulting from a slip-down incident (A) Panoramic radiograph presenting no fracture line. (B) Axial view of computed tomography (CT) shows a split fracture of the left parasymphysis (yellow arrow). (C) Coronal view of CT shows both condylar heads to be intact. (D) Three-dimensional reconstructed view of CT shows a split fracture (black arrow).
